# Fatality Investigation Report

OR 2003-18-1

## Auto salvage worker killed by unsecured car on transporter

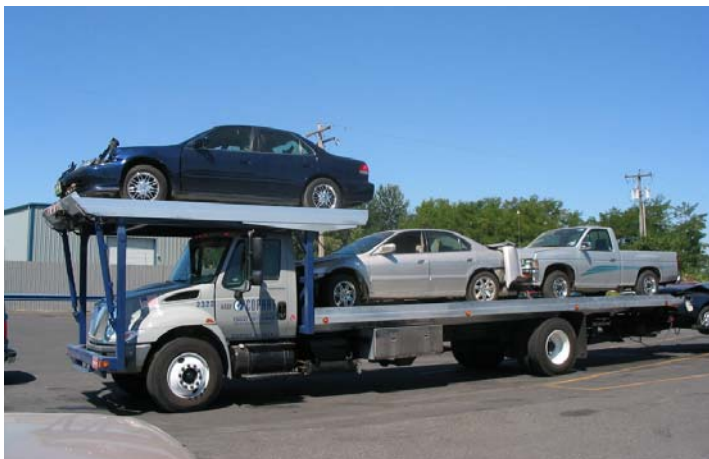
Typical vehicle hauling setup on a transporter.  
OR FACE Photo
