## FATALITY INVESTIGATION REPORT

### Skid-steer operator crushed while controlling the skid-steer from outside the cab.

**REPORT#:** 2018-08-1

**REPORT DATE:** September 2019

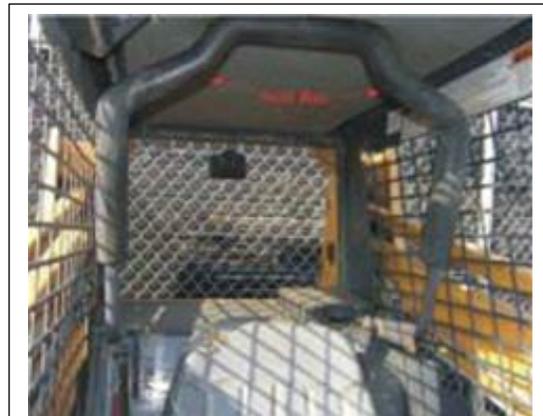
Photo 1: Seat bar (control interlock) of a skid-steer shown in raised position. (Photo from Department of Labor, OSHA, see Reference)

- **Recommendation #1: Employers should ensure that employees operate a skid-steer inside of the cab and should not bypass its safety features.**

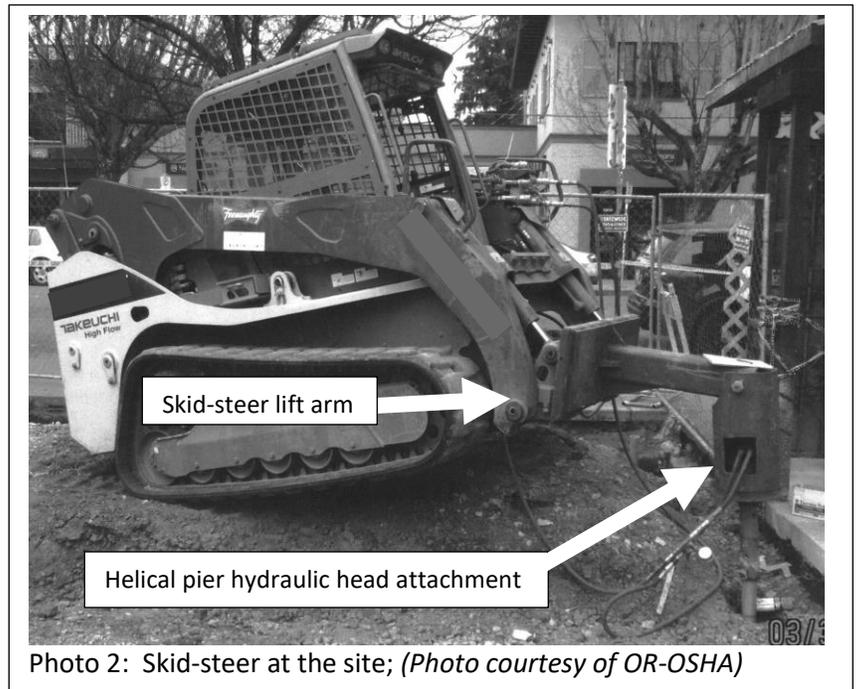
Video surveillance camera at a nearby business recorded the event. The operator stepped outside of the cab, left it running while attempting to release the pressure from the pin connecting the skid-steer's helical head attachment (which drives the helical pier to appropriate depth) to the installed helical pier. He positioned himself in front of the cab and in between the lift arms front frame rail cross member.

Photo 2: Skid-steer at the site; (Photo courtesy of OR-OSHA)

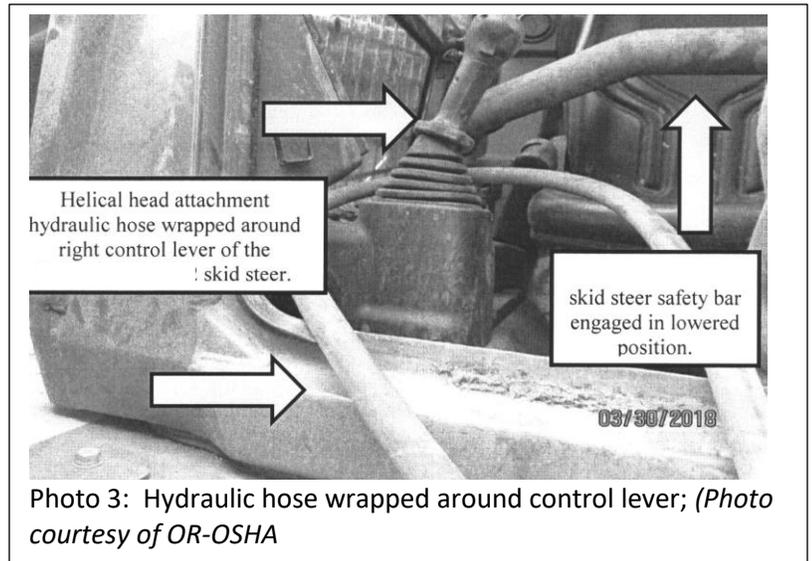
A hydraulic hose connected to the head attachment had been wrapped around the right control lever and pulled the control lever towards the front of the skid-steer (see Photo 3). When the operator pulled the safety bar (also known as seat bar-see photo 1) down it engaged the functions of the equipment and the right control lever caused the lift arms to lower, crushing the operator.
