FATALITY INVESTIGATION REPORT

Crab fishing vessel capsizes and drowns three crew members

REPORT#: 2016-06-1, 2, 3 **REPORT DATE:** Mar. 2020

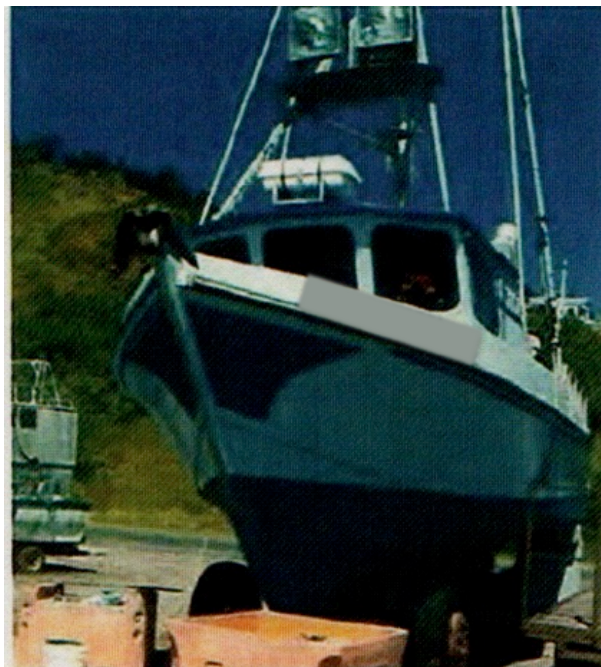
Photograph of the vessel several years prior to the incident.
