REPORT#: 2018OR40

Newly hired lighting technician electrocuted while working night shift—Oregon

Oregon Fatality Assessment and Control Evaluation Program

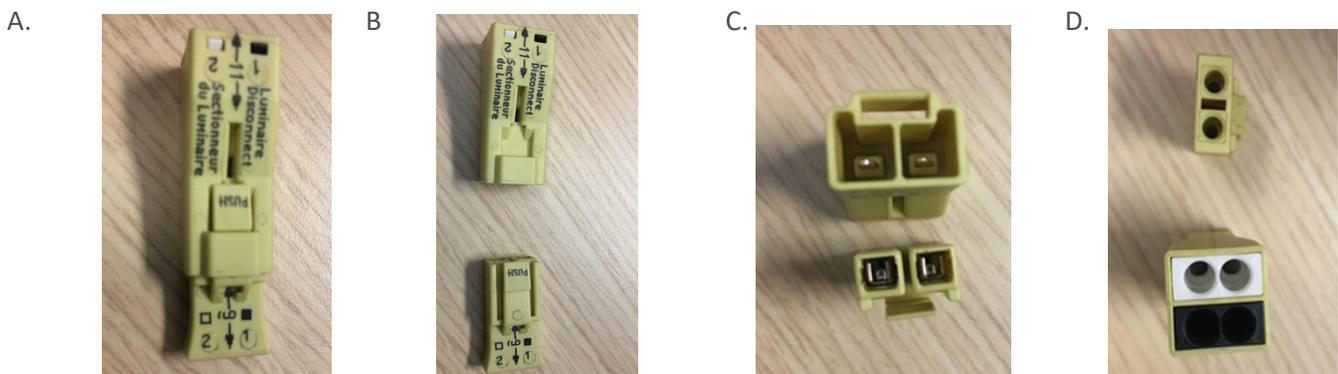
The decedent had been employed with a staffing agency for approximately 3 weeks, which, according to co-workers, was the extent of his experience in the electrical trade. The prime contractor had won a bid to replace fluorescent light fixtures with LED light fixtures in all 30+ Oregon stores of a national retail chain. The prime contractor then hired a staffing agency to contract lighting technicians to do the work. The decedent and the rest of the 6-person lighting technician crew had completed lighting fixture replacement in 11 stores in the 3 weeks prior to the incident. Because the decedent did not have any prior electrical experience, this 3-week period served as his on-the-job training. The technical manager, a journeyman electrician, who resided in California, did not inspect any stores in Oregon. Some of the lighting systems in the stores had previously been retrofitted with quick disconnect circuits required by National Electrical Code (NEC) Article 410.130(G)(1) that states “for existing installed fluorescent luminaires without disconnecting means, a disconnecting means must be added when a ballast (a regulator for current) is replaced” (NEC, 2011). This is so that maintenance workers can replace fluorescent bulbs without having to turn off the circuit breaker to the lighting system. In the store where the incident occurred, about 60% of the light fixtures were not retrofitted with the quick disconnects.

Image 1. Luminaire (i.e., “quick”) disconnect in different orientations. A. connected. B. Pulled apart. C. Looking inside at terminal connection points. D. Looking end-on, at wire feed points.

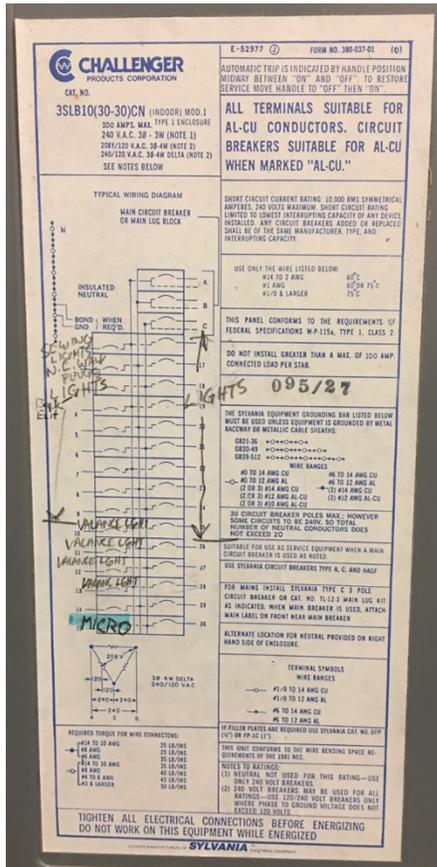
The foreman of the lighting technician crew located what he thought was the main lighting panel, a 208/120V single-

phase panel (See images 2 and 3). However, the 208/120V panel was for accent lighting only.

Image 2. Information sticker on outside of 208/120V single-phase electrical panel box. Note some circuits are labeled “lights”. These are for the accent lighting in the store.

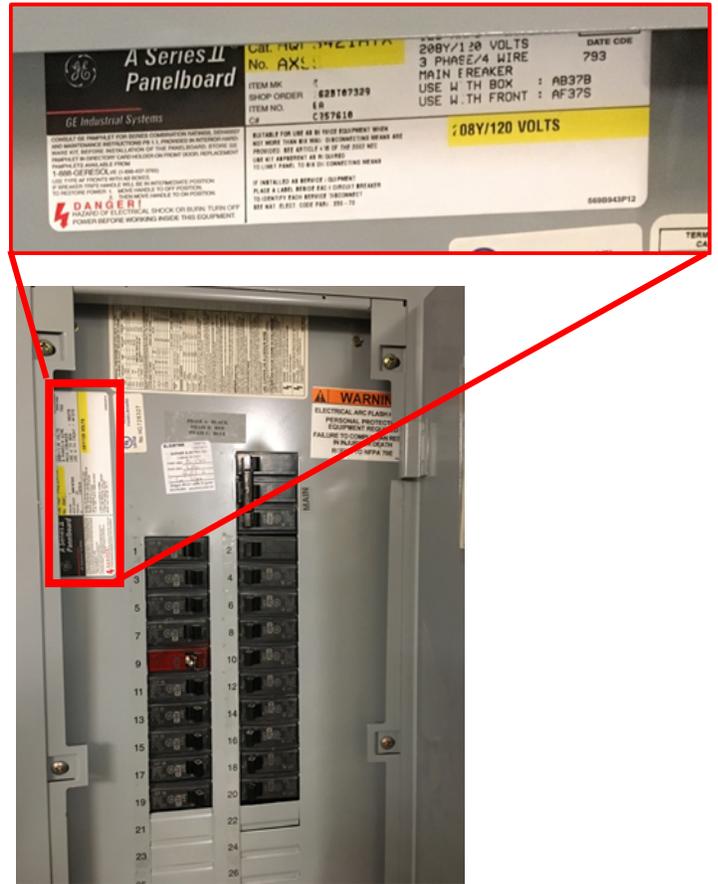
Image 3. 208/120V electrical panel controlling accent lighting and store outlets, with close-up of information sticker on inside of the breaker panel box. Note this is a 3-phase panel.

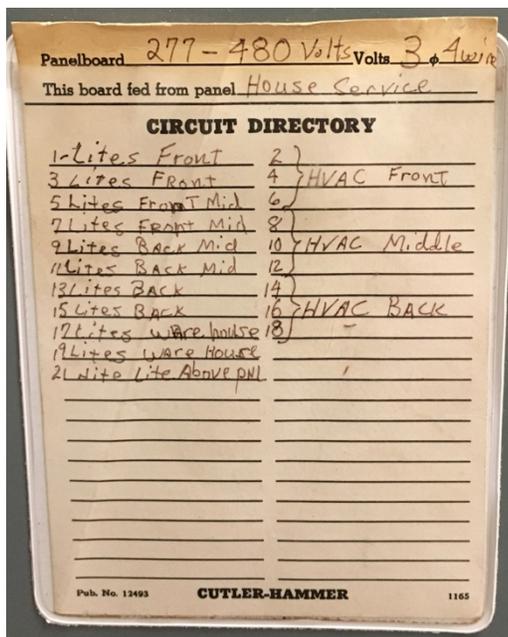
The main store lighting circuits were in another panel, on a 480/277V 200A 3-phase panel (See images 4 and 5). There was also an automated lighting system on third (emergency) circuit panel. The automated lighting system powered store lighting at night and in the event of a power failure. This panel had an override switch that, when pushed, would turn on the store lights for approximately 40 minutes. During the work, the foreman designated one of the crew members to stay on the ground and supply other crew members on the scaffolds and scissor lifts with materials for the light fixture replacement. The person on the ground was also designated to regularly go up to the mezzanine level and push the emergency circuit panel override button to turn the store lighting back on. Lighting technicians worked in different sections of the store and were not necessarily working near one another.

Image 4. Information sticker on outside of 480/277V 200A 3-phase electrical panel box. This panel contains the main store lighting circuits.

Recommendation #2: Employers should ensure live circuits are de-energized, especially when employees are working with bare wires to install luminaire disconnects, and ensure employees use appropriate lockout-tagout devices on de-energized circuits.

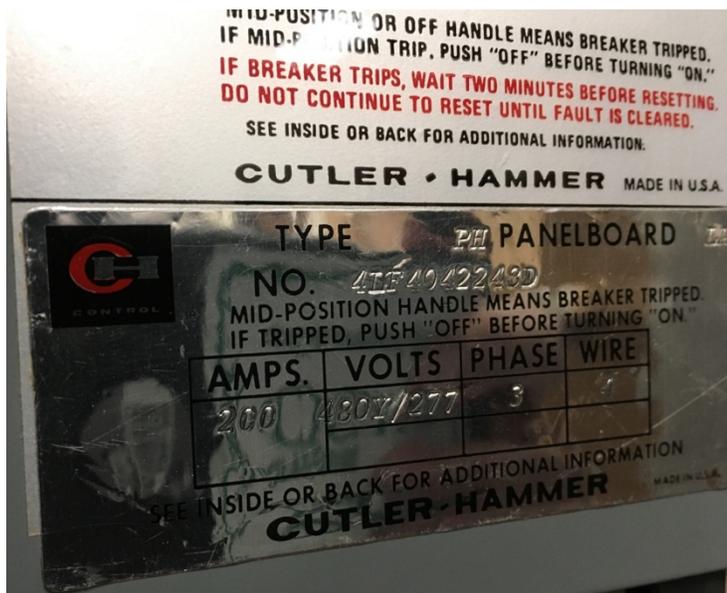
Image 5. Close-up of sticker on inside of 480/277V 200A 3-phase electrical panel box.

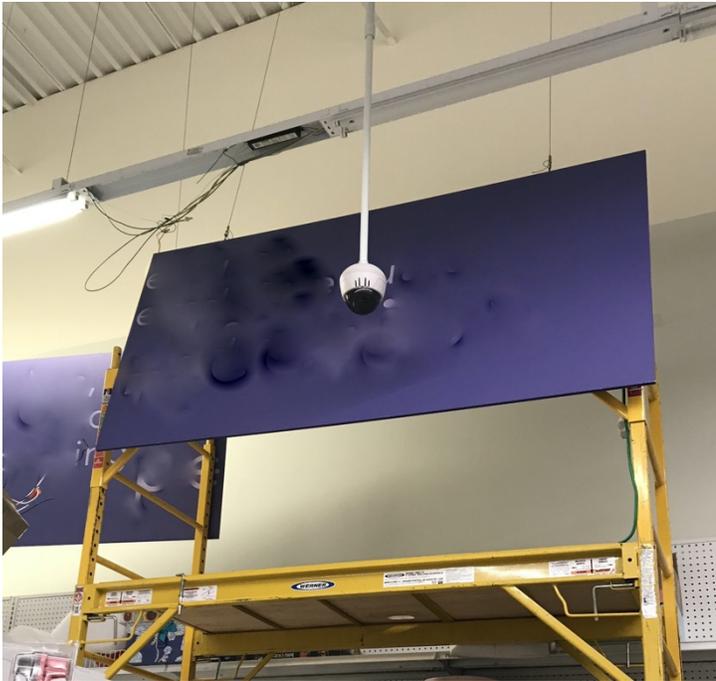
The energized lights were suspended from the ceiling with metal braided wire. Signage, also suspended with metal braided wire from the ceiling, was in the direct path of where employees were working with energized wires, while standing on metal scaffolds or scissor lifts. Employees reported moving signs to the side of their scaffold or scissor lift to work on some light fixtures. This was the case for the decedent while working on the light fixture where he was electrocuted (See images 6 and 7).

Image 6. Light fixtures and signage suspended from the roof by metal braided wire. Scaffold location recreates where decedent was working at the time of the incident. Writing on signs obscured for report.

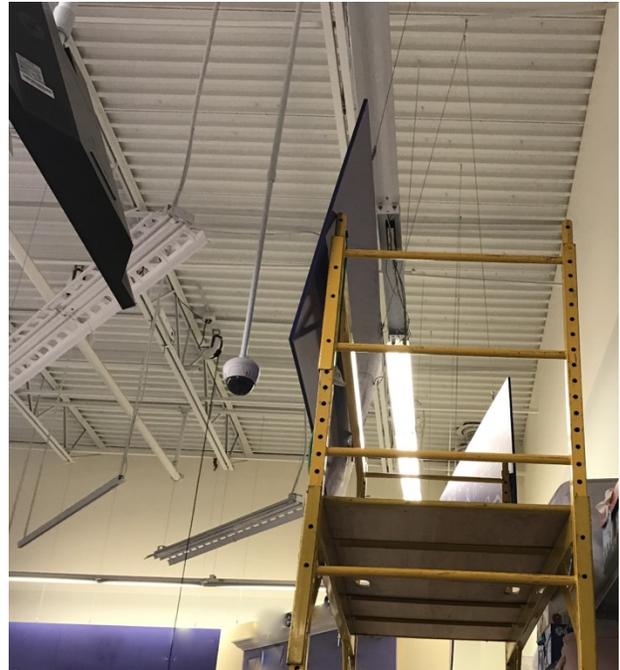
Image 7. Different angle of light fixtures and signage suspended from the roof by metal braided wire. Scaffold location recreates where decedent was working at the time of the incident.
