**REPORT#:** 2020OR010    **REPORT DATE:** December 7, 2020

## Forklift Operator Crushed by Full Pallet of Soft Drink Cans - Oregon

#### **Oregon Fatality Assessment and Control Evaluation Program**

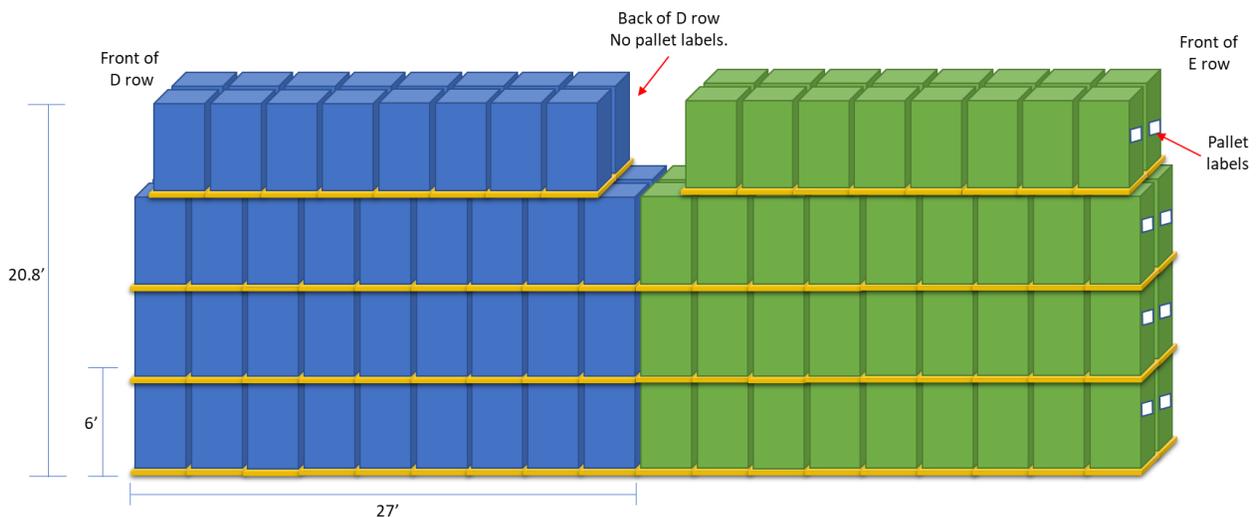
Product stored on the warehouse floor is placed there by the manufacturing forklift operators, who stack pallets 2 across, 4 layers high, and 9 pallets deep, except for the 4<sup>th</sup> layer, which is 8 pallets deep. Pallet rows are arranged back-to-back (*See Image 1 on following page*) so that pallet labels are on the front side of a pallet row.

**Image 1. Diagram of the back-to-back pallet row configuration utilized for product stored on warehouse floor.**

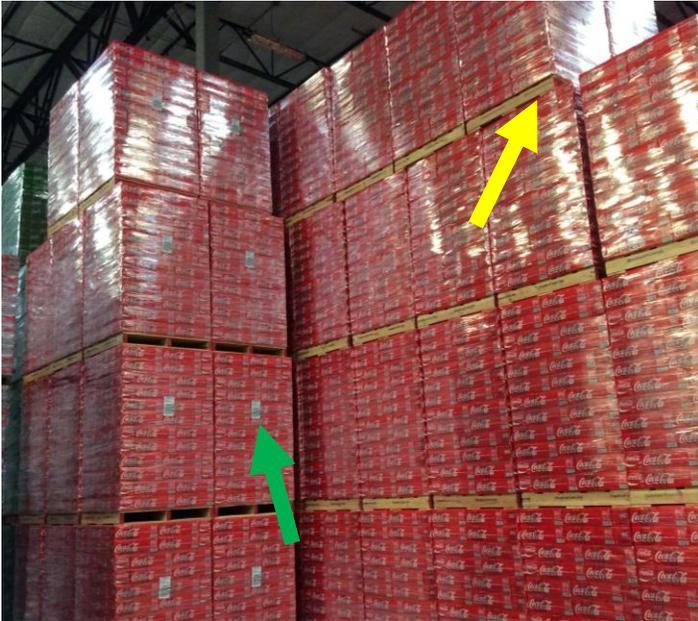
The 4<sup>th</sup> layer is offset from lower layers. The pallets of the 4<sup>th</sup> layer are placed so the front edge is offset behind the front edge of the 3<sup>rd</sup> layer (*See Image 2*). The last pallet at the back of the 4<sup>th</sup> layer last two pallets on the 3<sup>rd</sup> layer (*See Image 3*), which is why the 4<sup>th</sup> layer is only 8 pallets deep. This offset technique, combined with the weight of a pallet, stabilize the pallet row.

**Image 2. Front of pallet row. Note top (4<sup>th</sup>) pallet layer offset behind 3<sup>rd</sup> layer (yellow arrow). Also, note pallet labels with barcodes on shrink wrap, indicating this is the front of the pallet row (green arrow).**

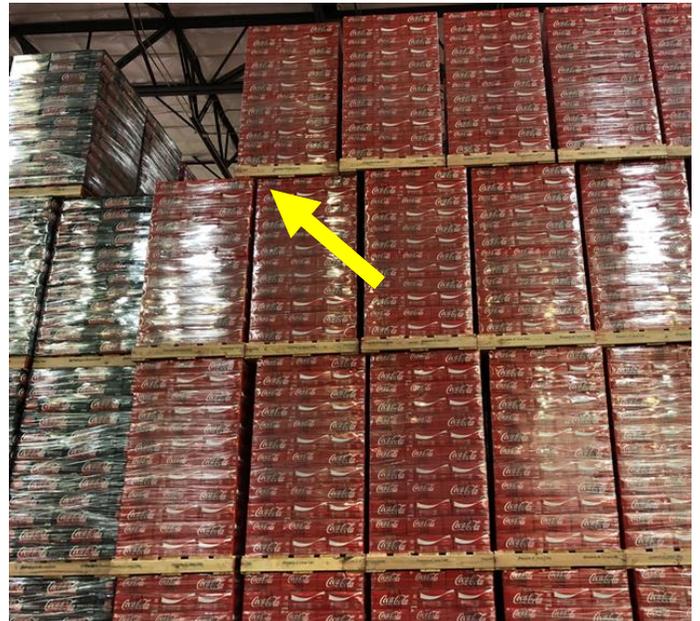
**Image 3. Back of pallet row. Note offset of top (4<sup>th</sup>) pallet layer overhangs rear edge of 3<sup>rd</sup> layer (yellow arrow). Also note back of pallet row abuts back of adjoining pallet row containing a different product.**

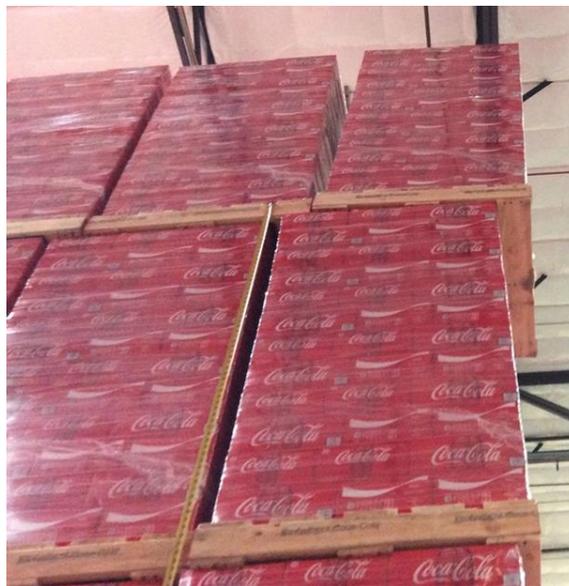
The incident occurred in the warehouse on a Friday, February 28<sup>th</sup>, 2020 at 4:27pm, approximately an hour into the beginning of swing shift. The decedent's task assignment that day was to retrieve palletized product from the floor and move it to the staging area for custom order fulfillment. The IMS directed the decedent to pull product from D1-116 pallet row and relocate it to the custom order fulfillment staging area. However, there was no product in the pallet row D1-116. For an unknown reason, the decedent pulled the 3<sup>rd</sup> layer from the back of adjoining E1-117 pallet row instead, and in doing so, 8 cases fell off of one of the pulled pallets. Because this was the back of the row, the decedent most likely did not see the 4<sup>th</sup> layer from his location inside the forklift. When the decedent lifted the 3<sup>rd</sup> layer and pulled it, it is likely this action dragged the 4<sup>th</sup> layer toward the edge, creating an even greater overhang (*See image 4*). Pulling the 3<sup>rd</sup> layer out from under the overhanging 4<sup>th</sup> layer is likely what caused the 8 cases to fall off of the 3<sup>rd</sup> layer pallet.

**Image 4.** Side view of end of pallet row where incident occurred. Top (4<sup>th</sup>) pallet layer overhanging 3<sup>rd</sup> layer and leaning away from top pallet row. The pallet next to this leaning pallet was the one that fell on the decedent.

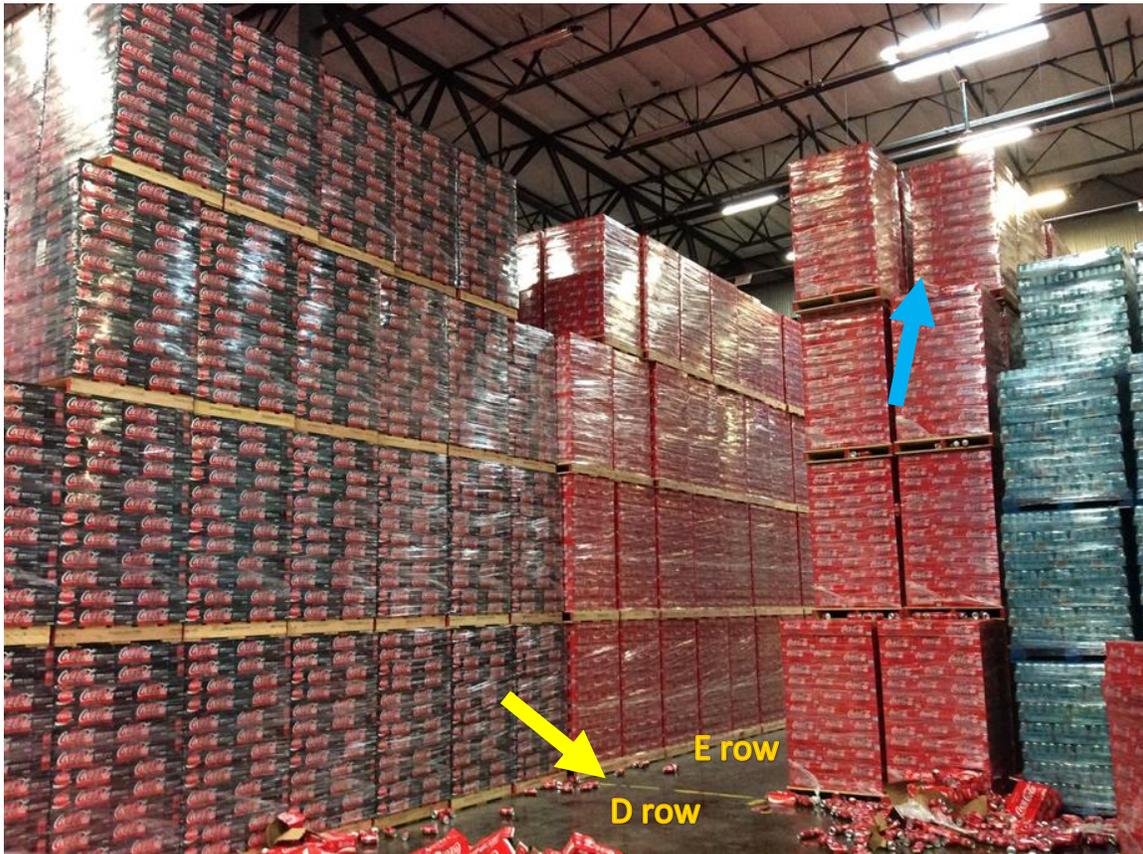
The decedent placed the 2 pallets pulled from the 3<sup>rd</sup> layer of E row on the floor near the pallet row, and pulled the 2<sup>nd</sup> layer from the back of E row, placing it on the floor near the pallet row as well. This was to ostensibly to reach some of the fallen cases from the 3<sup>rd</sup> layer pallet that were on the top of the 2<sup>nd</sup> layer. The decedent left the area to retrieve a containment pallet, a special pallet with a plastic grid on top and a solid trough on the bottom, designed to hold leaking product so it can be moved to the spillage/wastage area in the warehouse. The decedent returned to the back of E row with the containment pallet, shut off his forklift, walked to the back of E row and began picking up the spilled product. The 4<sup>th</sup> row pallets, destabilized when the decedent removed the lower layers (*See Image 4*), were now overhanging and tipping away from the E1-117 pallet row, toward the empty D1-116 pallet row. While the decedent was cleaning up the spilled product at the back of E1-117 pallet row, the pallet on the right side of the 4<sup>th</sup> row (*See Image 5*) fell down onto the decedent, striking him in the head and upper body, causing massive internal injuries.

**Image 5.** Looking at front of D row and the back of E row. Note 1: The faded yellow line on the floor that marks the end of one pallet row and the beginning of another (yellow arrow). Note 2: The pallets at the end of E row do not have pallet labels on the shrink wrap, indicating these pallets are at the back of a row. Note 3: Most of the product on floor were on the pallet on the 4<sup>th</sup> layer (light blue arrow) that fell on top of the decedent. Eight additional cases fell off one of the pallets the decedent pulled from layers 2 or 3 that the decedent was cleaning up when the incident occurred.

First, while there were visual cues that the decedent was located at the back of a pallet row (yellow line on floor, no pallet labels), there were no engineering controls to physically prevent a distracted employee from pulling product from the wrong side of a pallet row, and creating a serious, and in this case, fatal struck by hazard.

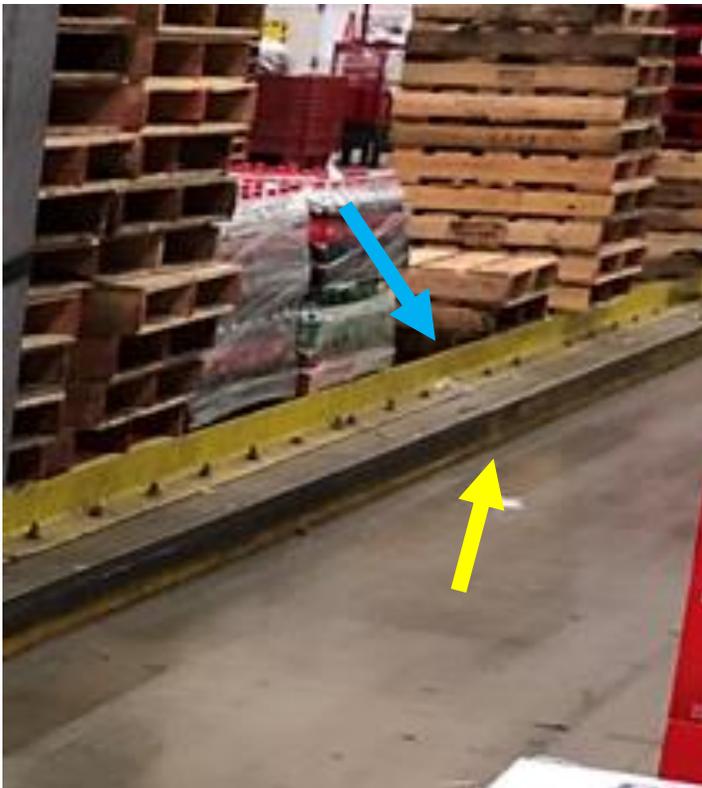
Image 6. Metal rails installed into concrete floor at the warehouse. Yellow and blue arrows mark end of each row. Rails prevent pulling product from back of adjoining pallet row. Rails were not installed in the area of the warehouse where the incident occurred.

**Recommendation #1:** Ensure warehouse layout and pallet stacking procedures incorporate sufficient engineering controls to prevent distracted employees from inadvertently destabilizing multi-layer pallet rows.

Discussion: The warehouse floor in the pallet row storage area was painted with a yellow line, delineating the end of a pallet row. In addition, metal rails had been installed into the concrete floor in some sections of the warehouse, to prevent material moving equipment from pulling products from the back of pallet rows (*See Image 6*). However, there were no rails installed in the section of the warehouse where in the incident occurred. A disadvantage of using floor mounted metal rails is that it doesn't prevent a distracted forklift operator from removing product from the 2<sup>nd</sup>, 3<sup>rd</sup> or 4<sup>th</sup> layer of the pallet row. A better solution would be to use a warehouse retractable curtain wall (*See image 7*), that is not only a visual cue, but also a physical barrier marking the end of the pallet rows. An internet search returned several brands of warehouse curtain walls available.

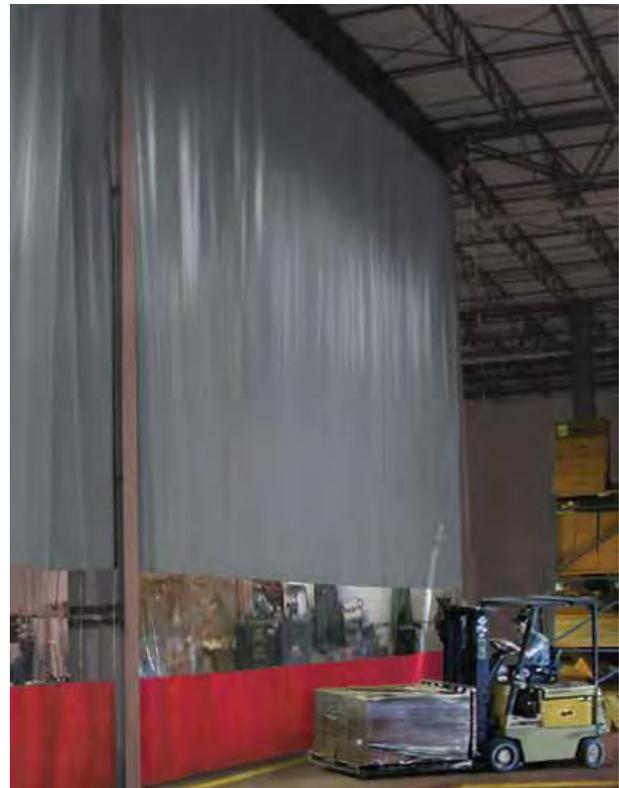
Image 7. Example of a retractable warehouse curtain wall, that would create a physical barrier between pallet rows, while also allowing for visibility through curtain wall at pedestrian or forklift operator height. Photo credit: TMI, LLC warehouse partitions sales brochure (TMI LLC, 2020).
