Fatality Investigation Report

OR 2016-16-1

Construction worker killed when trench collapsed

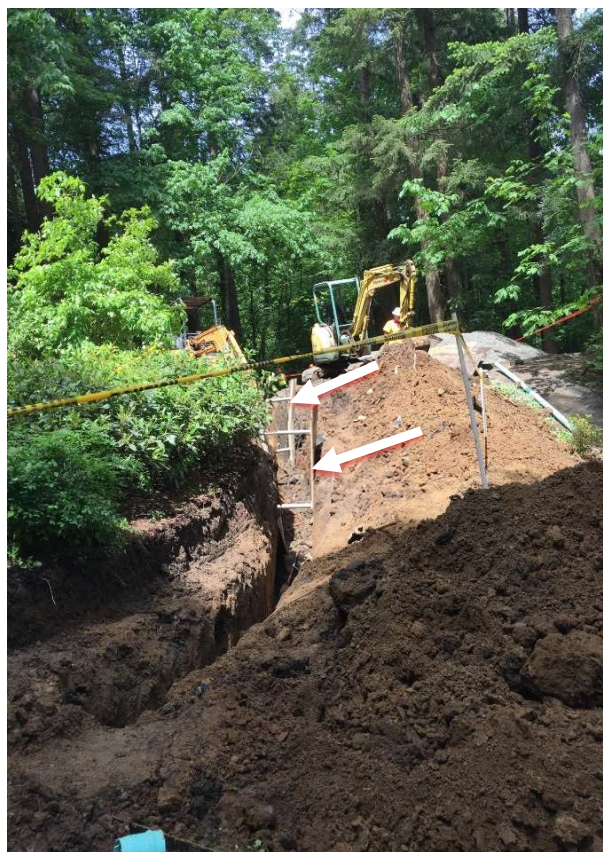
On May 5, 2016, a 29-year-old construction worker employed by a small excavation contractor was killed when the trench he was working in collapsed and buried him in approximately 6 feet of dirt. The worker was part of a crew installing a sewer pipe at a residential property. The trench was 10 feet deep and approximately 3 feet wide in the area where the collapse occurred. The collapse occurred in an unprotected area of the trench, between two pieces of shoring that were spaced 15 feet apart (see Figure 1).

Figure 1. View from front of house: area of incident showing placement of shoring; collapse occurred in between the two pieces of shoring spaced 15 feet apart (indicated by arrows)

The trench collapse occurred when decedent was working in an unprotected area of the trench between two pieces of shoring that were spaced 15 feet apart. The specific task being performed by the decedent at the time of the incident is uncertain. It was reported that he may have been checking the grading of the new sewer line. Other evidence suggests he may have been hand digging a high spot of soil or preparing to put in a pipe connector.

- Employers who have employees working in trenches that are 5 feet deep or deeper must select and install appropriate protection systems for the conditions present to protect workers from cave-ins. For trenches less than 5 feet deep, examination by a competent person for potential cave-in indicators is required.

- Trench protective systems may include shoring, sloping, and/or shielding. When shoring is selected as the appropriate protection system, the competent person must implement proper horizontal and vertical spacing, which includes placing the shoring the proper distance apart (in this case, a maximum horizontal spacing of 6 feet for Type C soils). However, the shoring in this case was spaced 15 feet apart (too wide to adequately support the trench wall) and it failed to protect the worker in the trench.

- In this case, the shoring was installed by the foreman, who was less knowledgeable in classifying soils and installing trench protective systems, and the competent person (the owner) did not oversee or inspect the installation.
- The competent person observed the shoring spaced too far apart but did not stop the work to correct the hazard it presented.

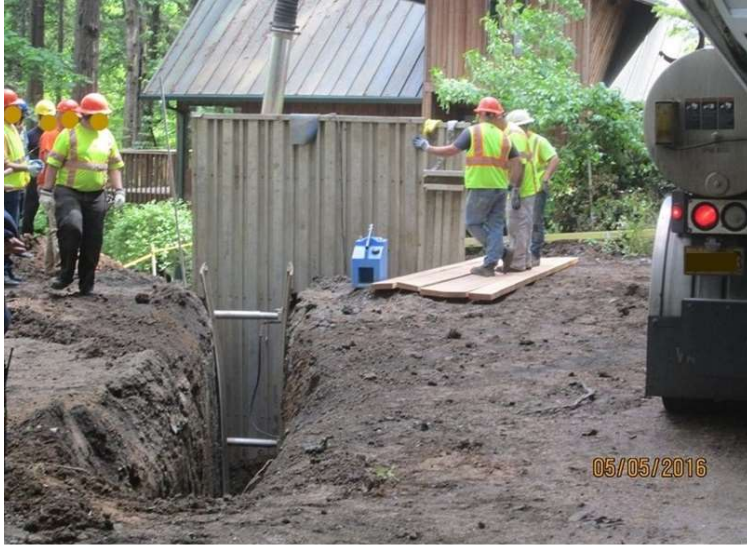
When the trench collapsed, co-workers called 911 and attempted unsuccessfully to locate and dig the worker out. When emergency responders arrived, their first task before commencing rescue and recovery efforts was to shore up the trench to prevent risk of additional collapse and injuries (see Figure 2). Emergency responders spent several hours recovering the worker's body.

Figure 2. Emergency responders preparing to install a trench box before starting rescue and recovery work, to prevent risk of additional collapse and injuries

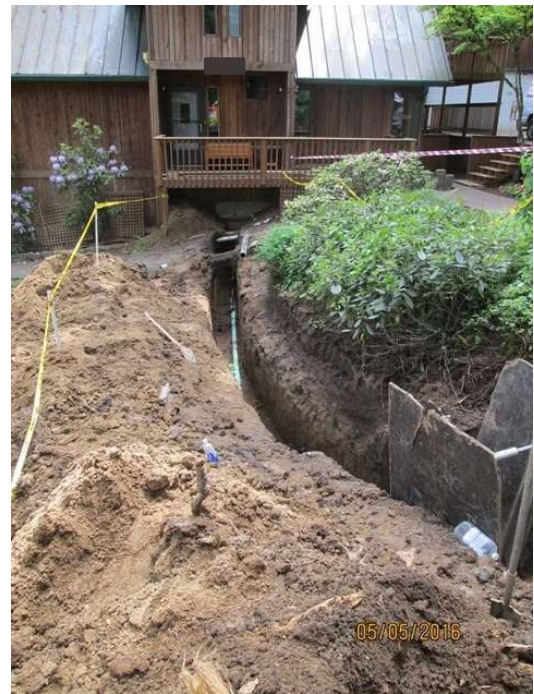
On the day of the incident, the decedent and a co-worker were working in the trench in front of the house (see Figure 3). As shown in the photos, the property was heavily wooded, and soil conditions around the property varied (see Figures 1 through 4). Two pieces of aluminum hydraulic shoring were installed in the trench. The foreman had installed the shoring. Evidence suggests that the foreman was less knowledgeable and experienced than the employer/owner (competent person) in installation of shoring systems. It was also reported that the competent person did not inspect the shoring before work started or during the work shift, as required.

Figure 3. View of trench work area in front of house

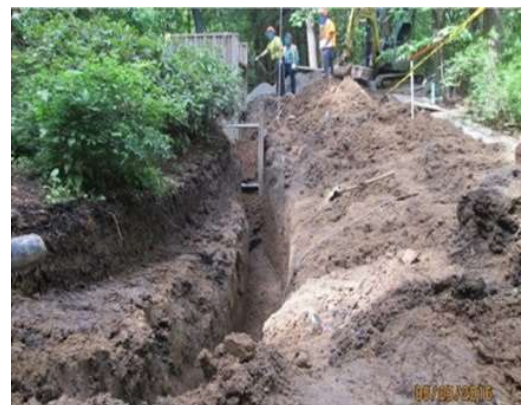
Figure 4. View from house showing trench work area and general soil conditions

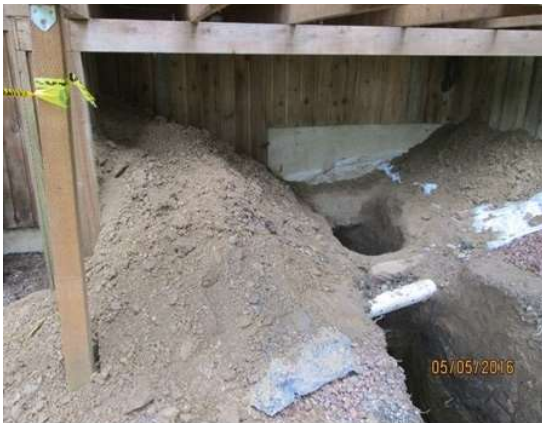
Figure 5. View of work area under deck of house where spoils had been placed at the open edge of the trench

Another hazard identified was the placement of excavated soil (spoils) on the edge of the trench that was located underneath the deck at the front of the house (see Figure 5). The spoils pile in this location was reported to be approximately 2 to 3 feet high. Spoils piles should be placed at least 2 feet from the edge to prevent creating a surcharge (meaning that it places extra pressure on the trench wall and affects trench stability). Alternatively, retaining devices may be used to prevent material from falling into trench.

In addition, while not specifically related to the collapse, the owner was reported to have said they would have been unable to install any form of shoring in the area underneath the deck (shown in Figure 5). Investigation findings suggest that while this may be the case, the contractor could have used alternative, safer practices to reduce cave-in risk in this situation. Examples could include use of boring equipment that could eliminate the need for a worker to enter a hole that cannot be protected with shoring or other protective systems.

- It also is important to consider any obstructions that might hamper the use of standard protective equipment, and to take the time to determine ways to abate any hazards and/or identify alternative safe measures for performing the work. Do not take shortcuts or ignore these conditions. For example, the property in this case was heavily wooded. Per discussion with an OR-OSHA investigator, a large tree root ball in one area of the trench obstructed an area where shoring would have been placed. One possible alternative for an obstructed area could be to use a trench box or shield instead of shoring.

Recommendation #5: Keep excavated soil (spoils) and other materials and tools at least 2 feet from the edge of the trench.

- Placing a load too close to the edge of the trench imposes a surcharge. This means that the spoils increase lateral pressure on the affected zone of the trench, thereby impacting the stability of the trench.
- In this case, the spoils from under the deck in front of the house were placed at the edge of the trench in that location.
